DEPARTMENT OF TRANSPORTATION

Quality Assurance and Source Inspection

Contract #: 04-0120F4Cty: SF/ALA Rte: 80 PM: 13.2/13.9File #: 1.28**WELDING INSPECTION REPORT****Resident Engineer:** Casey, William**Address:** 333 Burma Road**City:** Oakland, CA 94607**Report No:** WIR-026631**Date Inspected:** 31-Oct-2011**Project Name:** SAS Superstructure**OSM Arrival Time:** 730**Prime Contractor:** American Bridge/Fluor Enterprises, a JV**OSM Departure Time:** 1600**Contractor:** American Bridge/Fluor Enterprises, a JV**Location:** Job Site**CWI Name:** N / A**CWI Present:** Yes No**Inspected CWI report:** Yes No N/A**Rod Oven in Use:** Yes No N/A**Electrode to specification:** Yes No N/A**Weld Procedures Followed:** Yes No N/A**Qualified Welders:** Yes No N/A**Verified Joint Fit-up:** Yes No N/A**Approved Drawings:** Yes No N/A**Approved WPS:** Yes No N/A**Delayed / Cancelled:** Yes No N/A**Bridge No:** 34-0006**Component:** S.A.S. components**Summary of Items Observed:**

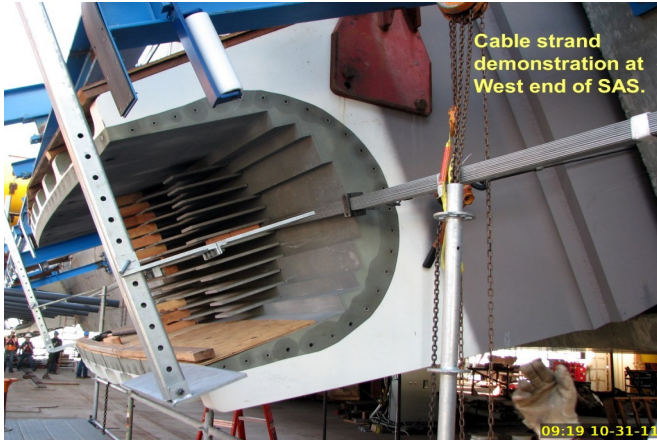
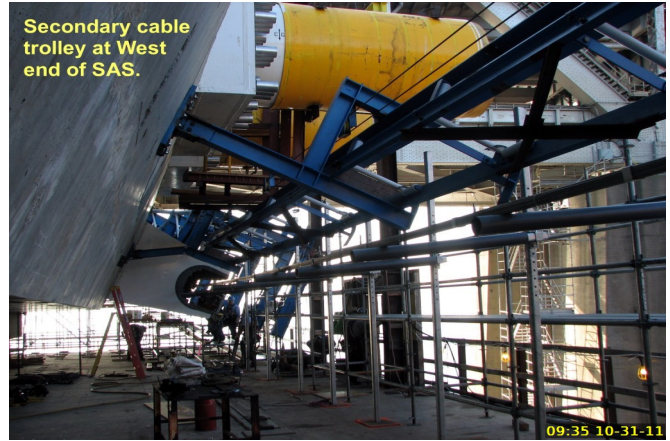
The QAI was present at the SAS structure on W2, for the contractor's presentation of the cable installation. The QAI noted that the contractor is demonstrating the means and methods of installing the cable strands in their proper orientation through the deviation saddles on the West end. The QAI noted that this procedure demonstrated did not include pulling / positioning of the cable strands. The QAI also noted that the cable strands being demonstrated are not for the permanent installation. See the attached photos.
